SERVICE BULLETIN

SUBJECT: Safety Inspection

EFFECTIVITY: L03 Single Point Shear Beam Load Cells

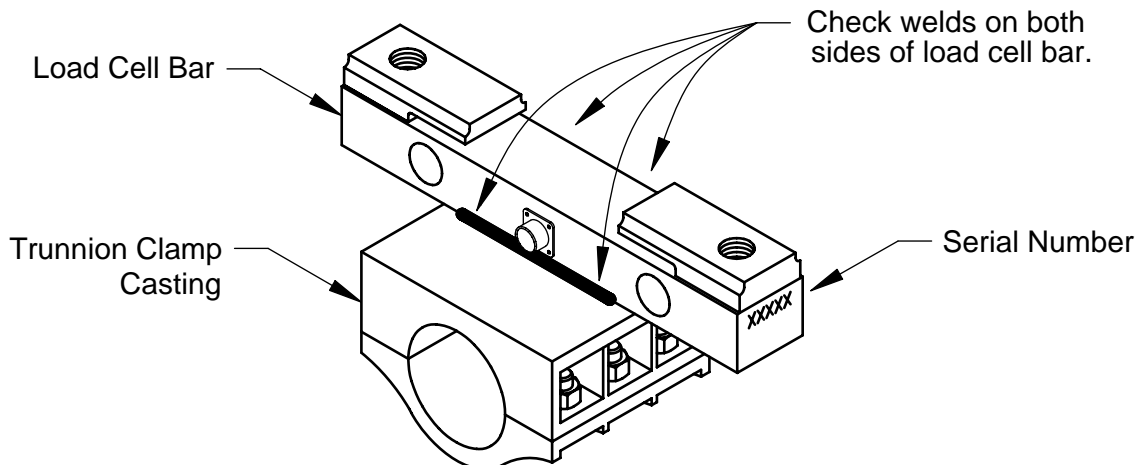
With use, some of these load cells have developed a crack in the weld that holds the trunnion clamp casting to the load cell bar. If a weld cracks, it starts at the end of the weld and runs along its length. If a load cell with a cracked weld remains in use, the crack will continue to grow. This could lead to a separation of the casting from the load cell bar.

Anyone using L03 Single Point load cells with serial numbers in the this reference group must visually check the trunnion clamp casting to load cell bar welds for any sign of a hairline crack developing in the weld. Both inboard and outboard welds must be checked. If a crack is found, the trailer should not be used until a replacement load cell is installed. If no cracks are found, this inspection should still be done on a monthly basis along with checking the bolt torque.
